Client: 20168A Siena at Green Valley

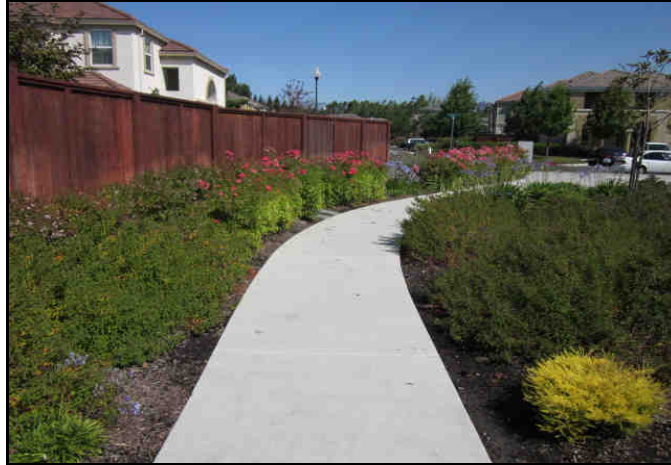
**Comp #:** 103 Concrete - Repair

Evaluation: No expectation to replace all areas at one time. This component provides funding for minor repairs in the event of cracking, lifting, and settling. Adjust funding as future conditions dictate.

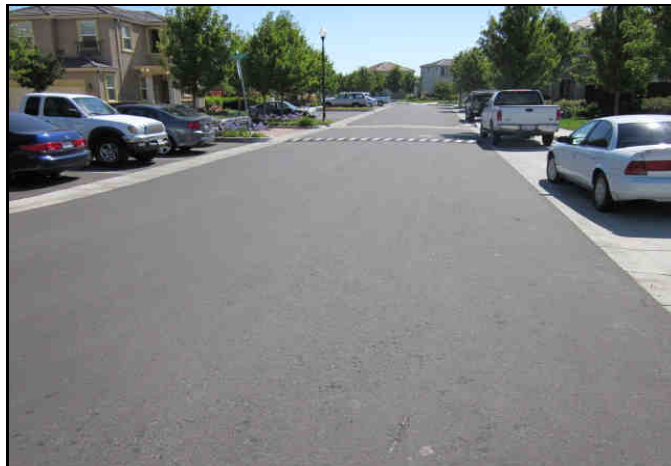
**Comp #:** 201 Asphalt - Resurface

Evaluation: Road well sloped to shed water. No signs of major cracks or abnormal deterioration. Seal asphalt (comp. #202) every 4-5 years to protect the integrity and prolong the need for costly resurfacing.

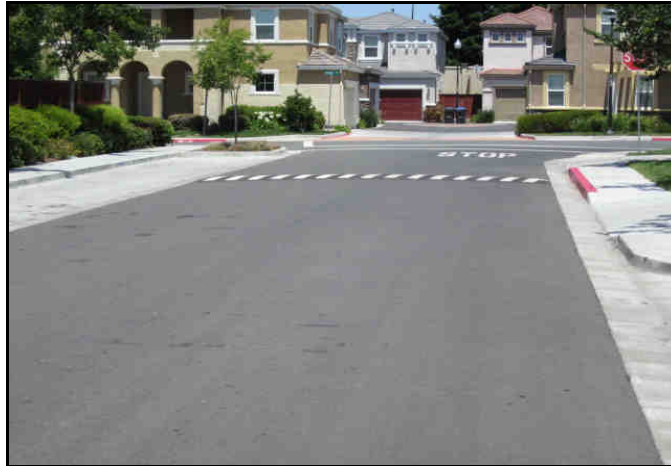
**Comp #: 202 Asphalt - Seal/Repair**

Evaluation: Seal coverage is thin, aggregate exposure noted in multiple areas. We suggest seal coating every 4 - 5 years to maintain appearance and protect asphalt from cracking, spalling, and potholes. Seal coating protects against damaging weather elements, while bridging small surface cracks and maintaining a uniform appearance over the inevitable patching and repairs needed in future years.

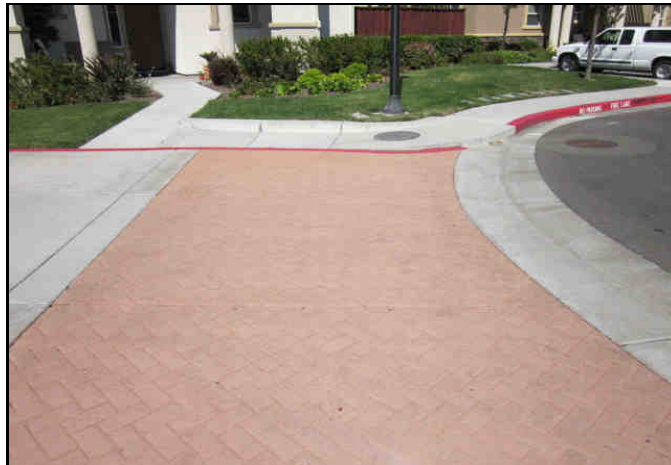
**Comp #: 206 Stamped Concrete - Repair (Partial)**

Evaluation: General surface wear and minor cracking noted. This component provides funding for partial repairs to the stamped concrete in the interval outlined below. Coordinate repairs with street sealing when practical.

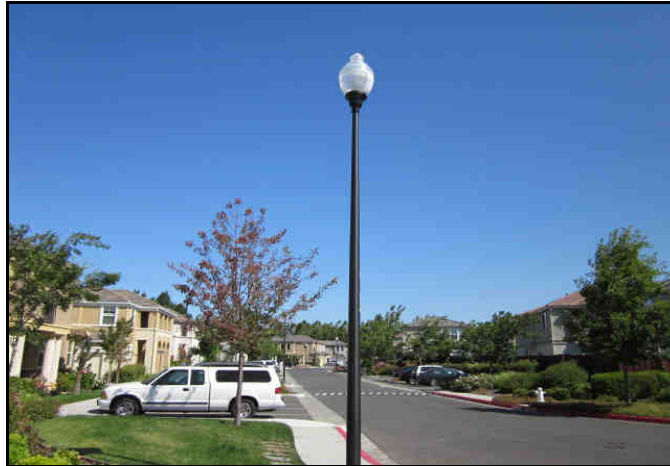
**Comp #: 320 Pole Lights - Replace**

Evaluation: Pole lights remain securely anchored to the concrete at this time. No significant rusting or other forms of premature deterioration noted at this time. Paint coverage is starting to become thin, we recommend repainting the metal pole in the near future to protect the metal against rapid deterioration. Handle painting as needed with funding from the operating budget.

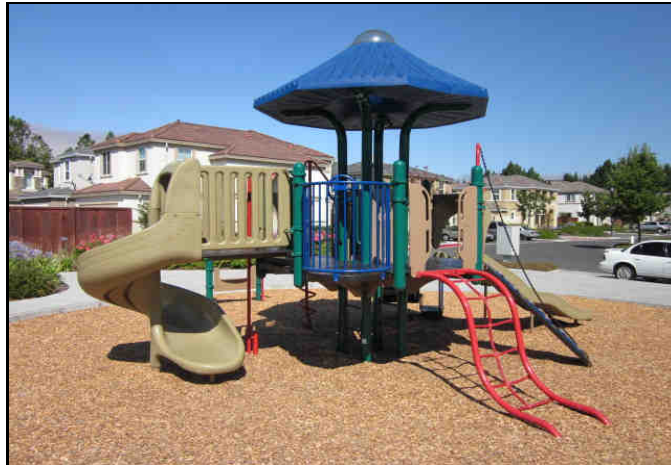
**Comp #:** 405 **Play Equipment - Replace**

Evaluation: Structure consists of (2) plastic slides and (1) central tower. Structure displays general surface wear that is common with usage. No rusting or detachment evident. A few areas of graffiti were noted and are scheduled to be removed. Play are was recently inspected by a professional inspector and no problems were noted.

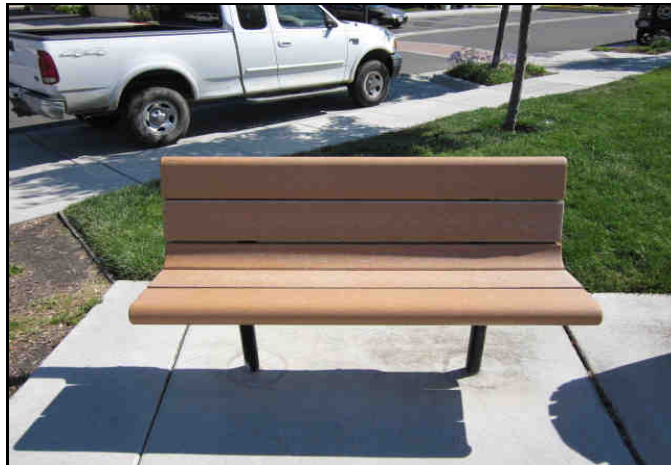
**Comp #:** 409 **Benches - Replace**

Evaluation: Synthetic wood benches are mounted in concrete and remain structurally intact at this time. The top surfaces are starting to fade from increased solar exposure. Expect to replace the top surfaces of the benches in the interval outlined below.

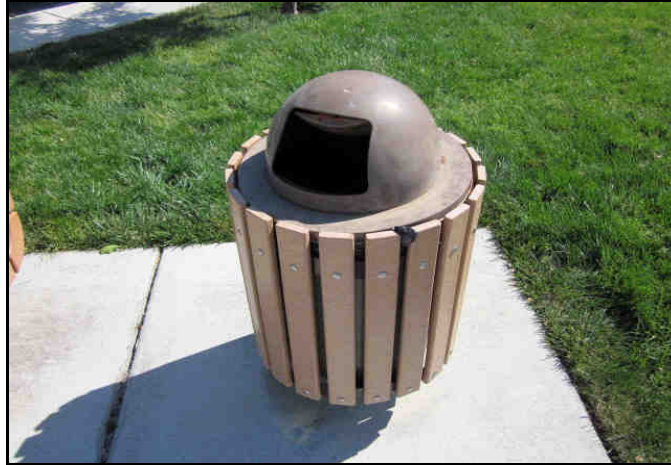
**Comp #:** 410 Trash Cans - Replace

Evaluation: Current conditions are fair, metal top is starting to fade from solar exposure. Replacement cost does not meet the minimum threshold to qualify as a Reserve component. Handle replacement as an operating expense.

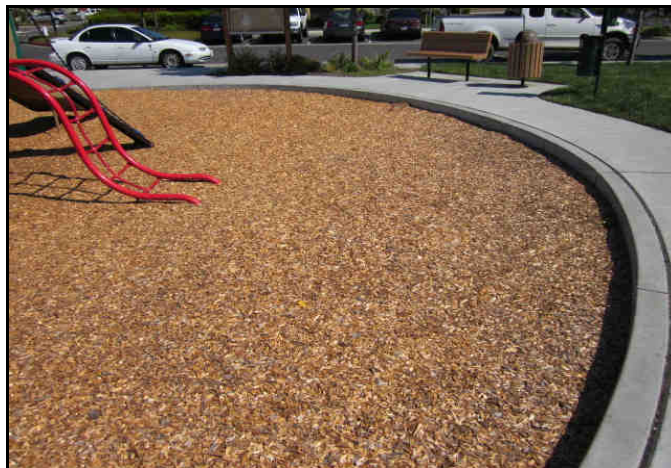
**Comp #:** 412 Tot Lot Surface - Replenish

Evaluation: This component provides funding for replenishment of the wood chips around the play structure. No expectation to completely replace all chips at one time however anticipate the need for periodic replenishment to maintain adequate surface coverage.

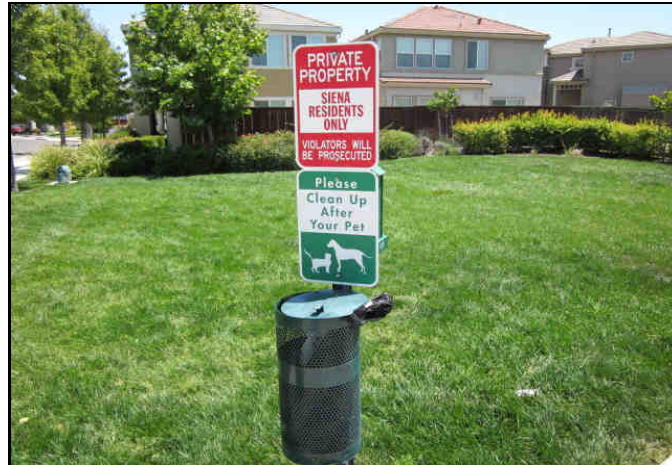
**Comp #:** 413 **Pet Station - Replace**

Evaluation: Replacement cost does not meet the minimum threshold to qualify as a Reserve component. No abnormal conditions noted at this time. Handle replacement as needed with funding from the operating budget. No Reserve funding necessary at this time.

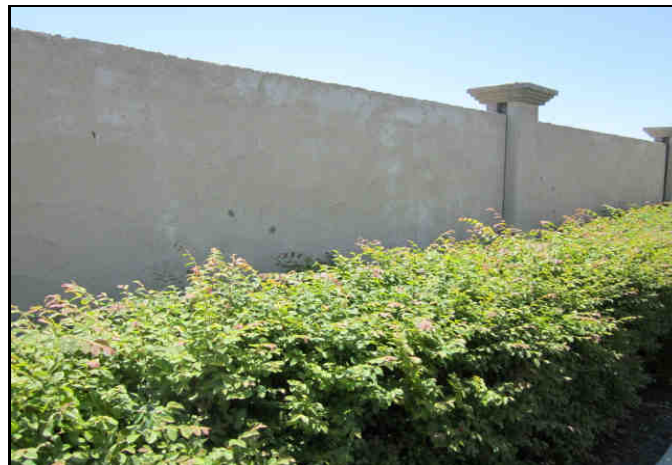
**Comp #:** 501 **Sound Wall - Repair (Partial)**

Evaluation: This component provides funding for partial repairs to the perimeter sound wall. The association is only responsible for maintaining the areas adjacent to the common area. The other sections of the perimeter wall are the maintenance responsibility of the city of Fairfield or the adjacent homeowner. Wall is in good condition at this time. No indications of premature deterioration noted.

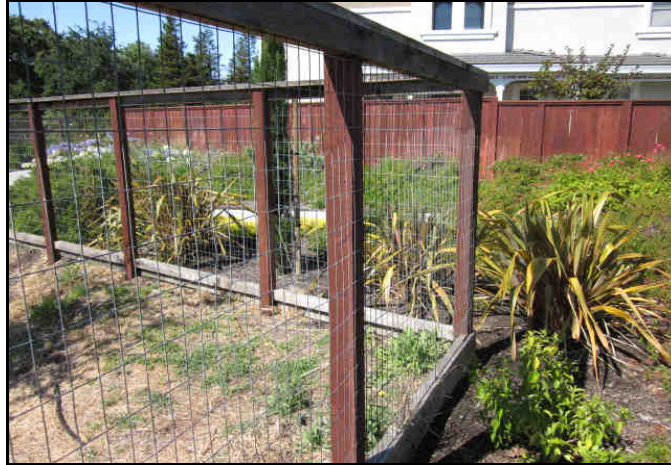
**Comp #: 504 Wood/Wire Fence - Replace**

Evaluation: Wood/wire fence is upright and intact at this time. Top surface is becoming dried out from increased solar exposure. No leaning or structural damage noted.

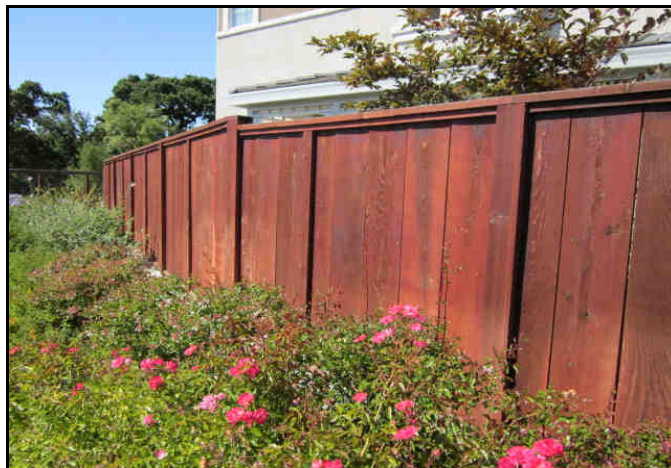
**Comp #: 505 Wood Fence - Replace**

Evaluation: The association is responsible for replacement of the wood fencing that faces the common area. The good neighbor fences that do not face the common area are the maintenance responsibility of the adjacent homeowners. Currently fence is upright and intact. A few minor areas of detachment noted on Malvasia Ct.

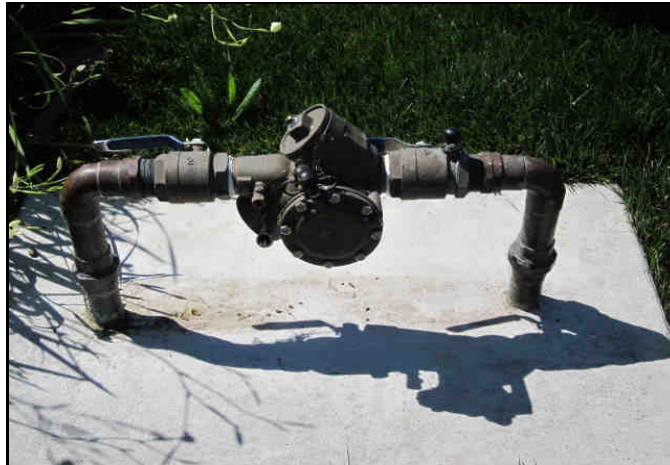
**Comp #: 1001 Backflow Devices - Replace**

Evaluation: Backflow devices appear to be aging normally at this time. No leaking or other forms or advanced deterioration noted. We recommend annual inspections by a licensed backflow specialist to ensure the devices are fully functional.

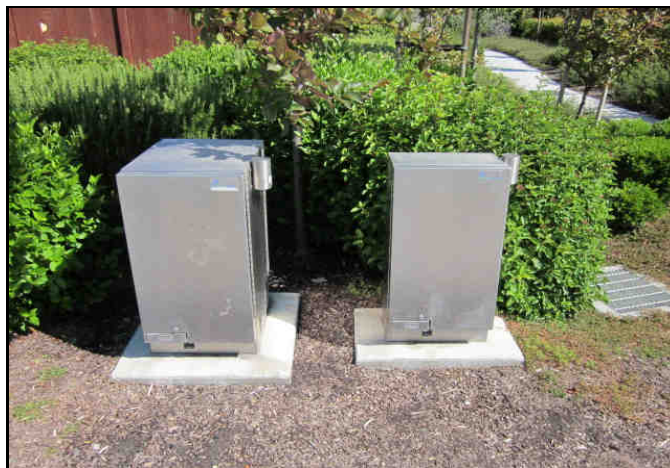
**Comp #: 1003 Irrigation Controllers - Replace**

Evaluation: Unable to inspect interior conditions at the time of the site inspection. No problems have been reported and we assume the devices are functioning normally at this time.

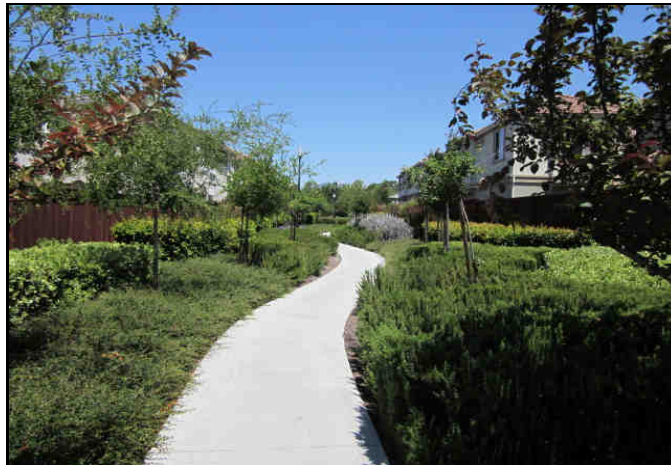
**Comp #: 1008 Landscaping/Trees - Remove/Replace**

Evaluation: This component provides funding to remove and replace common area trees and landscaping. The Association has replaced numerous trees to date and expects to continue to do so in the coming years. Adjust the funding provided by this component as future conditions dictate.

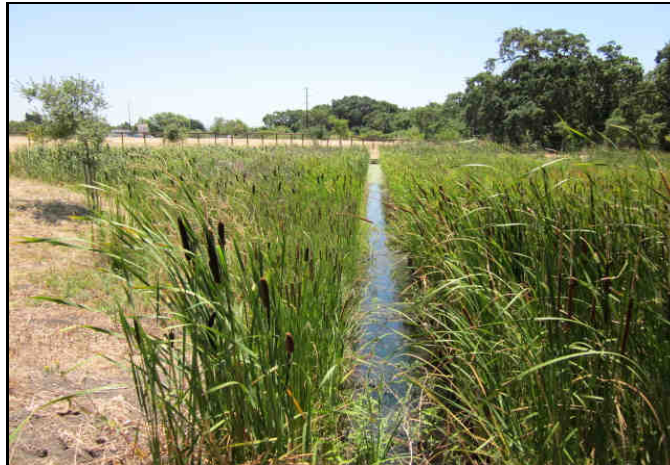
**Comp #:** 1010 Retention Basin - Repair

Evaluation: Inspect semi annually to ensure water is flowing properly. No expectation to completely replace the retention basin within the scope of this report. This component provides funding for partial repairs. Adjust funding as future conditions dictate.

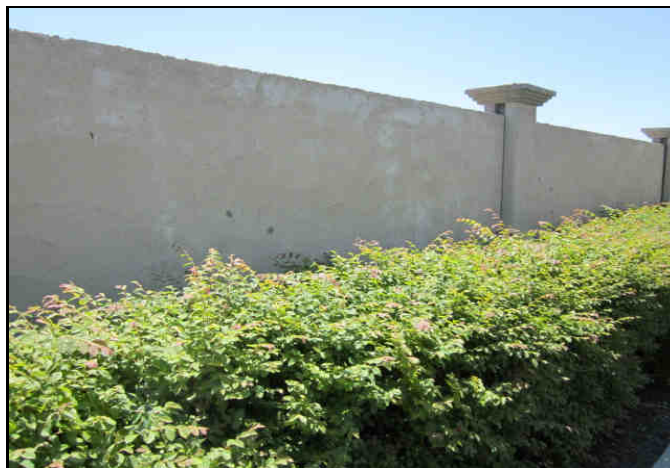
**Comp #:** 1105 Sound Wall - Repaint

Evaluation: The Association is responsible for repainting the sections of the perimeter wall that are adjacent to the common area. Currently paint appears to be aging well, select areas display general discoloration and slight fading.

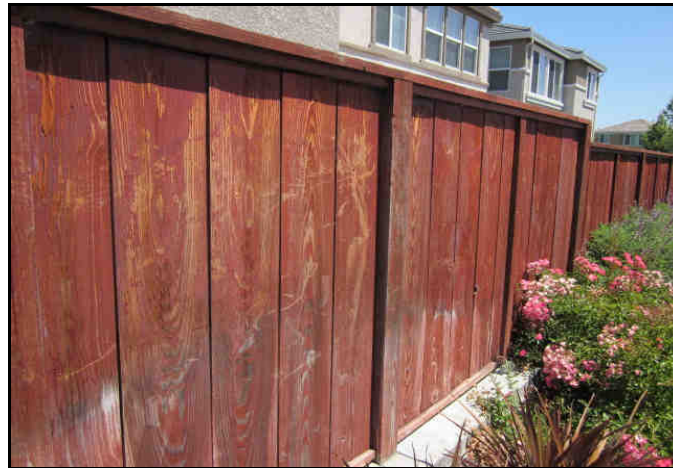
**Comp #: 1109 Wood Fence - Repaint**

Evaluation: Conditions vary from fair to moderate depending on location and solar exposure. Areas of increased solar exposure are fading and the underlying surface is becoming exposed. Sections of fencing on courts is semi protected and appear to be aging slower. We anticipate the need to repaint the fence towards the end of the fiscal year.

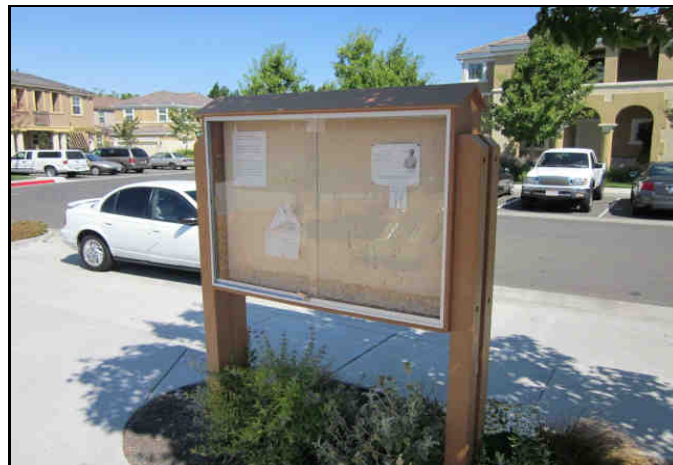
**Comp #: 1402 Signage - Replace**

Evaluation: (2) Bulletin Boards were installed in 2009 and are in fair condition at this time. The other street signage throughout the Association is intact and readable. This component provides a general allowance for replacement of the Association's signage. Adjust funding levels as future conditions dictate.
