Client: 20168A Siena at Green Valley

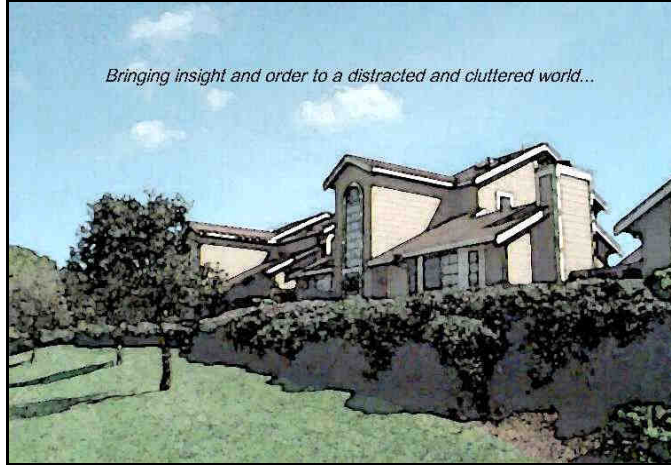
Location: HOA

Evaluation: Funding allocated for preparation of Reserve Study every 3 years to comply with Section 1365 of California State Civil Code. Next "site visit" report will be required for the in 2012 for your 2013 budget year.
